Homogeneous Area: M02

Material: Gaskets

Description: Gaskets in the flanged fittings throughout the HVAC system

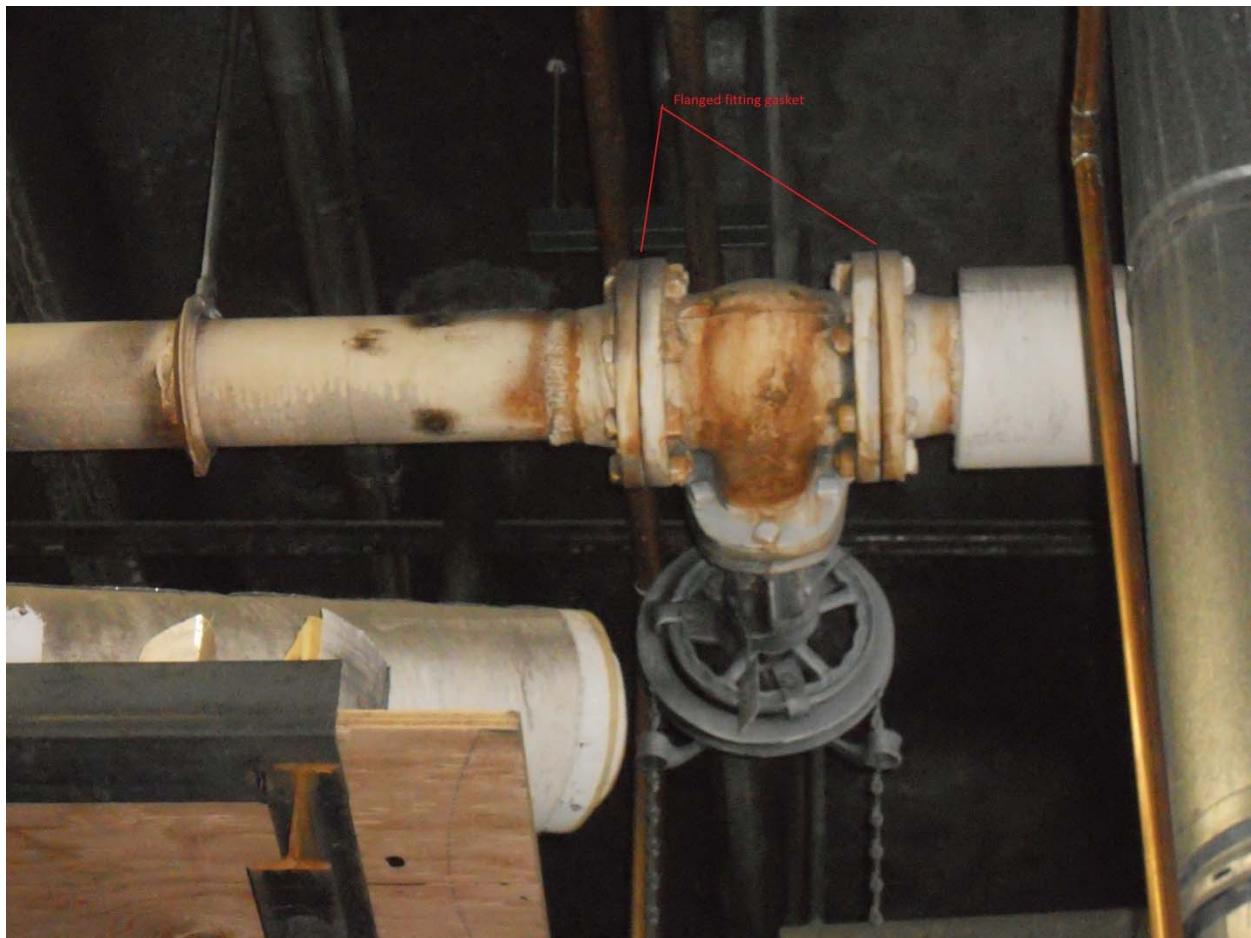
Location	Amount	Asbestos Content
Boiler Room and Pipe Chases	~100 exposed in boiler room, undetermined quantity in remainder of the HVAC system	65% Chrysotile

Example of flanged fitting gaskets.
